Wang, J, Heath, A & Walker, P 2013, 'Experimental investigation of brickwork behaviour under shear, compression and flexure', *Construction and Building Materials*, vol. 48, pp. 448-456.  
<https://doi.org/10.1016/j.conbuildmat.2013.07.025>

# **Experimental investigation of brickwork behaviour under shear, compression and flexure**

<sup>a</sup>BRE Centre for Innovative Construction Materials, Department of Architecture and Civil Engineering, University of Bath, Bath, UK.

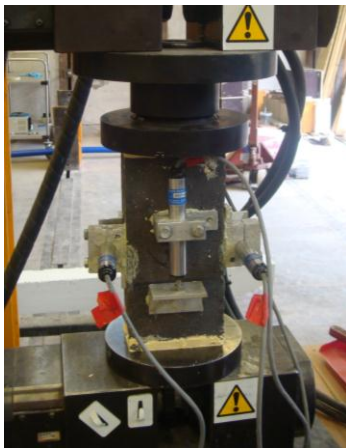
Figure 1 Experimental set up showing brick strain measurement

Four specimens were tested under uniaxial compression load to investigate the elastic properties of the brick. Linearly Variable Differential Transducers (LVDTs) were attached onto the face of units to measure the longitudinal displacement (Fig. 1). Load was applied using a 100 kN compressive machine in three load cycles for two of the specimens with a 0.1 kN/s loading rate, while the other two specimens experienced only one load cycle. Test results (Fig. 2) indicated a linear relationship between the stress and strain in the range of stresses tested up to 15 N/mm<sup>2</sup>, an average Young's modulus of  $2.5 \times 10^4$  N/mm<sup>2</sup> was calculated from the tests.

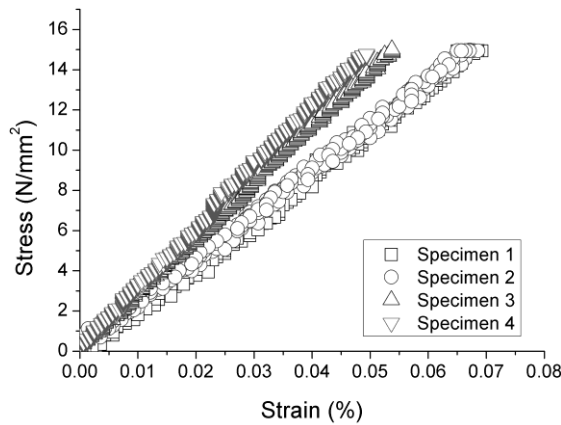
**Figure 2 Stress strain relationship of brick unit**

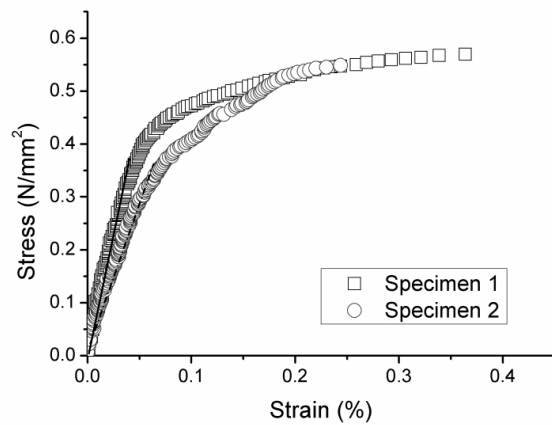
**Figure 3 Stress strain relation of mortar unit**

Three prisms measuring 40 mm × 40 mm × 160 mm were cast in steel moulds for the compressive and flexural strength test in accordance with BS EN 1015-11 [9]. They were tested after 28 days storage under 20 °C and 65 % relative humidity. The loading rates for compression and flexural were 0.5 mm/min and 0.2 mm/min respectively. Average compressive and flexural strengths were 0.74  $\text{N/mm}^2$  and 0.44  $\text{N/mm}^2$  respectively. Two prisms (135 mm × 75mm × 75mm) were made for testing of elastic properties, the same set up for the bricks were applied to the mortar. The test was carried out under load control with a loading rate of 0.02 kN/s. The stress and relationship is shown in Fig. 3. The stress increases linearly at the beginning and the gradient decreases gradually to zero as it undergoes plastic deformation. The maximum strain during the test for the two specimens was 0.27% and 0.38%, with an average elastic modulus of 700  $\text{N/mm}^2$  based on the linear stage under 0.05% strain.

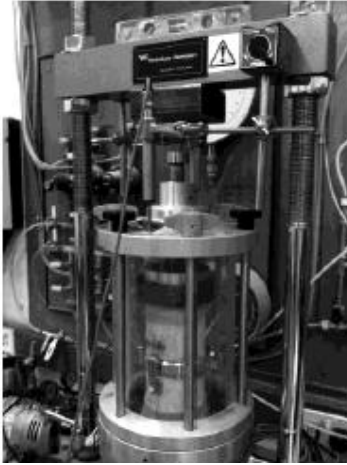
Figure 4 Triaxial test set up showing on-sample strain measurement

In addition to the conventional unconfined tests used for mortars, the mortar was subjected to triaxial testing, commonly used to define the strength of soil materials, in order to determine its stiffness, cohesion and frictional properties under increasing confining stress. Three cylinders with a diameter of 100 mm and height of 200 mm were prepared, as to simulate very weak mortar in old masonry structures and compared with previous tested results, they were tested after only 28 days storage in the laboratory conditions (20°C, 65% relative humidity). The specimens were tested under drained conditions and the designed confining pressures were 0, 0.2 and 0.4 N/mm<sup>2</sup> respectively. The setup for test was shown in Fig. 4; two transducers were attached on the top of the cell to measure displacement, and for the specimen with no confining pressure, a radial transducer and two axial transducers were fixed on the specimen to allow more accurate determination of small-strain properties. Tests were carried out under displacement control conditions and the loading rate was 0.5 mm/min. The Elastic modulus from the unconfined sample with on-sample strain measurement was similar to that for the mortar prisms. It was not possible to use on-sample instrumentation for the confined samples as they were within a latex membrane and the conventional fixing methods for on-sample transducers in soils did not work because of the cementation of the lime sample. The stiffness of the confined samples could not be accurately determined using external displacement measurements as compliance in the test system coupled with a stiff sample resulted in artificially low stiffness. The maximum principal stresses obtained are 0.43, 1.14 and 1.75 N/mm<sup>2</sup> for the samples with 0, 0.2 and 0.4 N/mm<sup>2</sup> confining stress respectively. The tested specimens were sprayed with Phenolphthalein, and the chemical reaction indicated that only the surface of the cylinders had carbonated as expected for a lime sample at early age. Additional carbonation would result in an increase in mortar strength [10], but this could take an unacceptably long time, particularly for the 100 mm diameter triaxial samples. Mortar carbonation rates are significantly influenced by interaction with the units within the masonry, with dewatering of the mortar by brick suction effects influence drying rates for the mortar and the resultant porosity. According to the Mohr-Coulomb theory, the cohesion and friction angle were determined as 0.115 N/mm<sup>2</sup> and 34 ° respectively (Fig. 5).

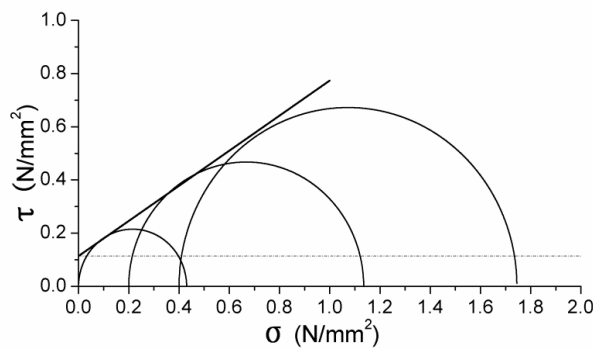
Figure 5 Mohr coulomb circles obtained from triaxial test

The smallest diameter circle in Fig. 5 represents the unconfined compressive strength and the value of  $0.43 \text{ N/mm}^2$  is much lower than that of  $0.74 \text{ N/mm}^2$  attained by the smaller prisms. This could be because of increased carbonation of the smaller sample, because of the different geometrical ratios (height: width was 1:1 for the smaller prisms but 2:1 for the triaxial sample), because increased moisture content of the larger triaxial sample which would not have fully dried or because of size effect. All of these factors would have resulted in an increased strength of the smaller prisms as measured, and this is an area requiring further investigation, but beyond the scope of this paper.

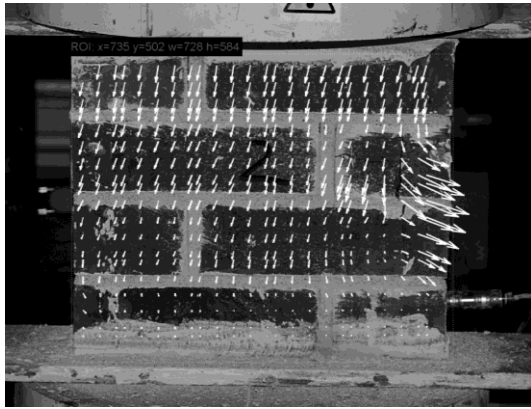
Figure 6 Small compressive wall test set up

Three small masonry walls with dimensions of 330 mm × 290 mm × 102 mm were produced for the study of stiffness characteristics. Fig. 6 shows the general arrangement of the test specimens. All the specimens were capped with dental plaster before testing in order to obtain a flat surface to ensure load was distributed uniformly. Two transducers were fitted on the surface to measure vertical movement; load was applied at a 2 kN/s rate until failure of the walls. The experimental results showed that all the specimens exhibit initially linear behaviour between the stress and strain with brittle behaviour at failure. The average compressive strength was 33 N/mm<sup>2</sup> and an average elastic modulus of 2550 N/mm<sup>2</sup> was calculated by taking the whole range of data in consideration. The characteristic compressive strength calculated in accordance with BS EN 1052-1 [11] is 24.7 N/mm<sup>2</sup>, and it is 38% higher than the design value from Eurocode 6 for these brick and mortar strengths, which is 17.9 N/mm<sup>2</sup>.

Particle Image Velocimetry (PIV) analysis was performed based on a series of pictures during testing. The general movement is illustrated by displacement vectors represented by the arrows which represent 20 times magnification of the real displacement (Fig. 6). The maximum horizontal and vertical displacements identified were 2.0 mm and 0.9 mm respectively by the analysis. It was noted that greatest strains were localised on the mortar before failure, but at failure one brick failed in tension induced by lateral expansion. This indicates that a longer wall with increased lateral restraint may not fail in this manner and that the test method may therefore yield conservative strengths.

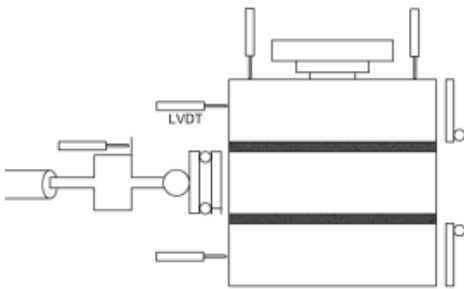
Figure 7 Schematic arrangement for triplet shear test

Fig. 7 shows the schematic arrangement of this test, two transducers were attached on the top surface, and one was fitted on the loading jack while another two were attached on the top and bottom brick. All the specimens were divided into five groups. The first four groups were tested under normal dry

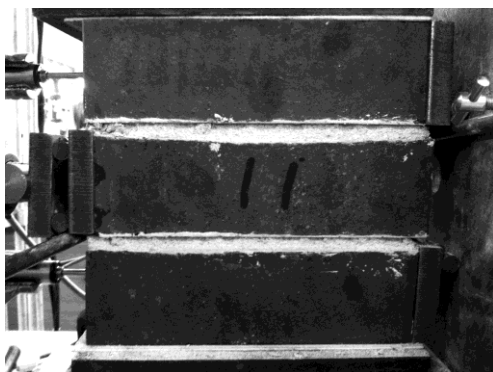
Figure 8 Shear failure under normal stress

conditions with different compressive stresses which are 0 N/mm<sup>2</sup>, 0.2 N/mm<sup>2</sup>, 0.6 N/mm<sup>2</sup> and 1 N/mm<sup>2</sup> respectively. There was one specimen in each group which load was applied through three loading cycles to about 33% of expected failure load and then loaded to failure (except for the 0 N/mm<sup>2</sup> normal stress condition). The specimens in the final group were put into water to achieve a saturated condition, and they were then tested under 0 N/mm<sup>2</sup>, 0.2 N/mm<sup>2</sup> and 0.6 N/mm<sup>2</sup> normal stresses respectively. The main failure mode observed was delamination at the interface, accompanied with some cracking of mortar at the corner (Fig. 8) and test results are listed in Table 1.

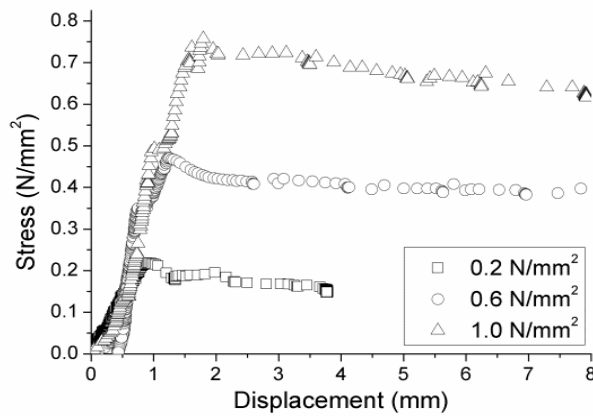
Figure 9 Load displacement curves under different normal stress levels

Fig. 9 shows the relationship between mean relative displacement of the central block to the adjacent ones and corresponding load obtained for the specimens under different stress levels. The stress increased almost linearly with the displacement until failure, and then behaviour was governed by the friction, which produced a relatively constant residual stress. Experimental work that has been done by Abdou et.al [17] on mortar joint behaviour showed similar response between shear stress and deformation. Their work was carried out under displacement control conditions, and so the load decrease after initial failure was gentler with the displacement. The gap for the displacement of the specimen under  $0.6 \text{ N/mm}^2$  at the beginning stands for the unloading and loading path for the last two load cycles, it can be concluded that the linear behaviour has been stiffened after the first load cycle. For the  $1 \text{ N/mm}^2$  stress level, as the load provided by friction is quite close to the maximum load, instead of abrupt load decrease after initial failure, the load decreased gradually accompanied with mortar crushing. The average vertical movement throughout the tests were plotted versus the

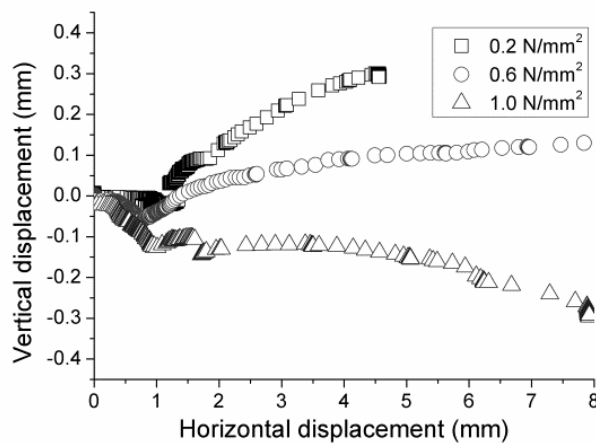
Figure 10 Vertical displacement under different normal stress levels

horizontal displacement in Fig. 10. As the normal stress applied, these specimens experienced an initial compression of 0.6 mm, 0.9 mm and 1.2 mm respectively. It can be seen from the chart that the specimens under  $0.2 \text{ N/mm}^2$  and  $0.6 \text{ N/mm}^2$  normal stresses dilated by 0.3 mm and 0.1 mm respectively after both joints opened, while the specimen under  $1.0 \text{ N/mm}^2$  stress level behave in the opposite way, it was compressed with a final displacement of 0.3 mm accompanied with the mortar cracking near the brick/mortar interface. This behaviour of increasing dilation under lower normal stresses is common in shear box tests on sands which have similar stress conditions to the triplet shear test.

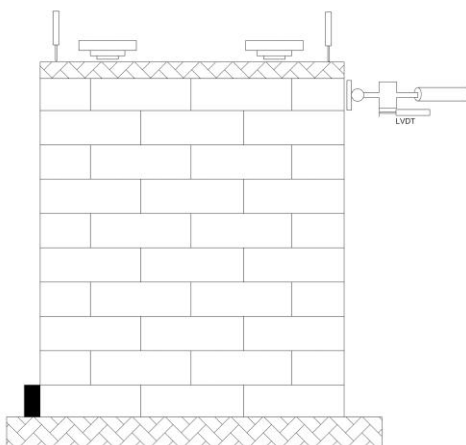
Figure 11a Test set up for shear wall 1

Two brickwork walls with dimensions of  $665 \text{ mm} \times 740 \text{ mm} \times 102 \text{ mm}$  were constructed for the evaluation of the in-plane shear failure under static compression load. Construction of these walls was performed manually by the same mason to ensure uniform workmanship, and they were built on timber stands for easy transportation and to avoid local damage. They were tested under two loading conditions as shown in Fig. 11a and 12a. The specified axial pre-compression stress was  $0.2 \text{ N/mm}^2$  applied using two jacks through low friction Teflon bridge bearings. A set of steel beams and timber frame was laid on the top and bottom to help distribute the vertical load uniformly. The applied load was adjusted manually during the test to maintain a constant stress level. Applying a constant stress at the top of the wall would allow horizontal movement and rotation of the top. Four transducers were attached on the top two at jacks, loading jack, and the reaction frame respectively to monitor the movement. For shear wall 1, the first course of the wall was horizontally supported by steel blocks, while the load was applied at the top course through the steel beam. For shear wall 2, both the bottom and top courses were horizontally supported against the reaction frame connected to a strong wall, while the load was applied at the fifth course through a steel plate. Care was taken to avoid out of plane movement during load application.

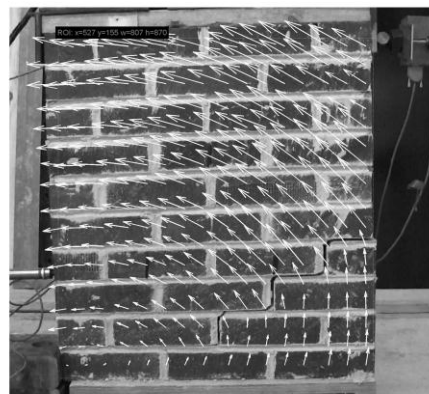
Figure 11b: Shear failure mode of wall 1(5 times magnification of real displacement represented by the arrows)

For shear wall 1, the observed failure mode is stepped cracking through the mortar joint of the bottom four courses as shown in Fig. 11b. The stepped failure across different courses is consistent with the theory proposed by Mann and the corresponding failure shear stress was calculated by provided equation [18] and gives a value of  $0.15 \text{ N/mm}^2$ . The detailed failure mode is greatly affected by the pre-compression load and material strength according to Senthivel and Lourenco [19]. The maximum horizontal and vertical displacement obtained from the PIV analysis was 18.2 mm and 10.0 mm respectively. The overturning of shear wall has been observed during the test, and lower and upper bound approaches have been developed by Milani [20] for the limit analysis of shear walls with overturning effects. The load displacement curve is characterised by approximately linear increase with several drops before reaching the maximum load, and then the load remains almost constant. The reason for the fluctuation is due to manual adjustment of normal load, which is inevitable given current test set-up as the load was applied by hand and could not be controlled automatically. The initial load displacement response before failure is quite similar compared with the results reported by Vermeltfoort [21] in his work on a shear wall under  $0.3 \text{ N/mm}^2$  compressive stress, except the large corresponding horizontal displacement when maximum load was reached, and this may be caused by the lower compressive stress and different loading system adopted here.

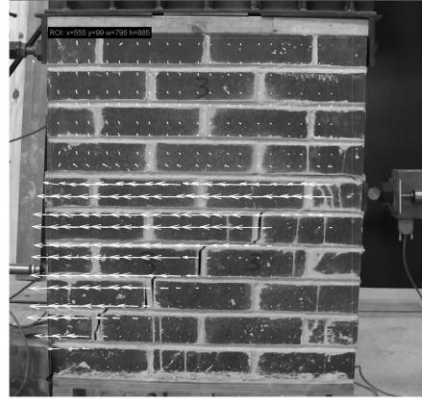
Figure 12b Shear failure mode of wall 2 (10 times magnification of real displacement represented by the arrows)

For shear wall 2, a similar failure mode was observed in the lower part of the wall while the wall failed in sliding along the loading course (Fig. 12b). The PIV analysis gave 7.0 mm and 1.0 mm for the maximum horizontal and vertical movement. The maximum shear stress and the trend of the load-displacement curve are consistent with the triplet shear test, the load increases linearly until the maximum was achieved, then dropped abruptly and remained constant thereafter. This has provided the evidence of potential possibility of using data from simple masonry specimens for the analysis of complex masonry structure, especially for the prediction of failure load. The load and displacement characteristics can be used for validation of future computer modelling.

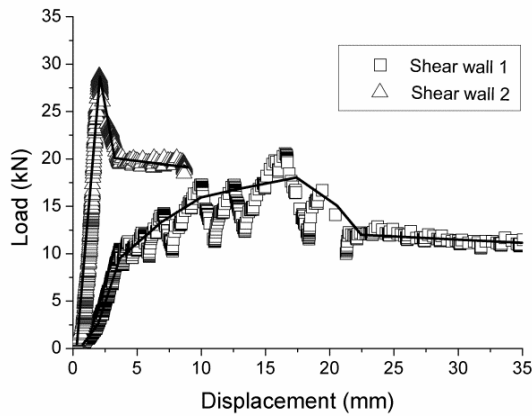
**Figure 13 Load displacement curves for shear walls**

The maximum shear failure loads obtained were 20.5 kN and 28.7 kN respectively for these two specimens, and the corresponding shear stresses were calculated as  $0.30 \text{ N/mm}^2$  and  $0.21 \text{ N/mm}^2$ . The applied load versus the corresponding displacement of the loading cell is plotted in Fig. 13. PIV analysis was performed based on a series of pictures before and after failure, it gives the general movement of each component represented by the arrows. The design value of shear resistance was then calculated by equation 1 given by Eurocode 6[16]:

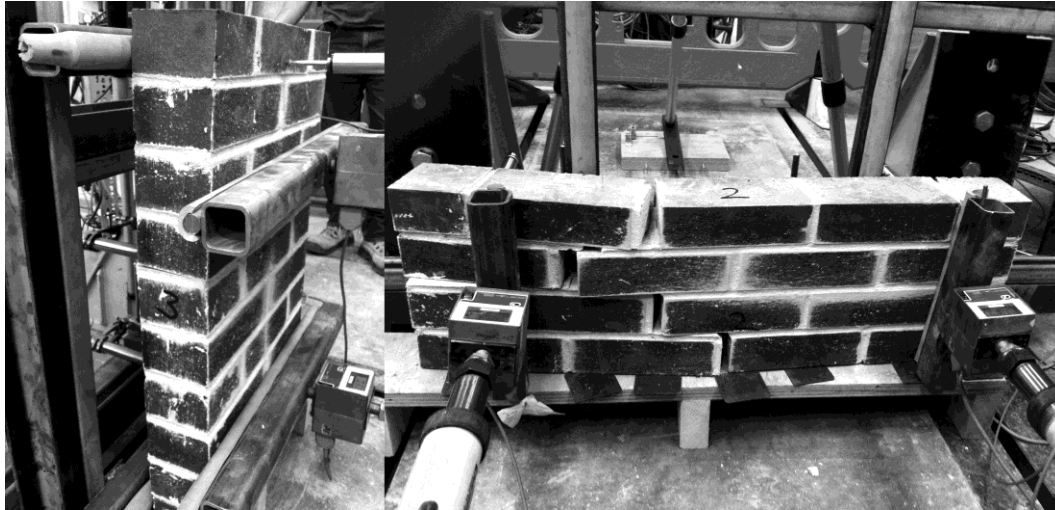
**Figure 14 Experimental set up for flexural strength tests**

The flexural strength with planes of failure parallel and perpendicular to the bed joint were determined in accordance with BS EN 1052-2 [23]. Five specimens were constructed for each condition and the general set up of these tests were shown in Fig. 14. Linear Variable Differential Transducers (LVDT's) were located at three points on each wallette, one near the mid-span and one near each support. Magnetic bases attached the LVDT's to unloaded elements of the test rig. Loading was applied at a slow and repeatable rate using a hydraulic jack until failure of the specimen.

For the tests with plane of failure parallel to the bed joints (left in Fig. 14), fracture planes occurred along the interface between the brick and mortar joint, and most of the planes located within the inner bearings except one specimen failed with the cracks happened between the inner and outer bearings on the top, indicating a shear rather than flexural failure. A combined failure along the joint interface and within the depth of mortar was observed for the tests with plane of failure perpendicular to the bed joint (right in Fig. 14), and all the fractures occurred within the inner bearings. All specimen shows similar behaviour in terms of the load displacement relationship, typical load displacement curves which include the post failure behaviour was plotted in Fig. 15 for the test with plane of failure perpendicular to the bed joint. The detailed results was summarised in Table 2.

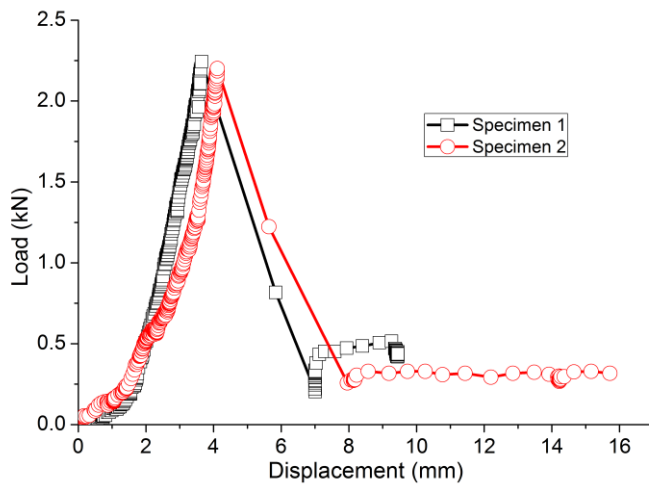
Figure 15 Load displacement relationships for wallette (displacement measured at mid-point)

The tests in both directions show similar behaviour in terms of the load displacement relationships. All graphs reveal an almost linear relationship as the application of load up to 25% of the failure load. The graphs become non-linear as the curvature increased until the ultimate load was reached. All the specimens failed instantaneous with an immediate and complete loss of strength. Fig. 16 shows a typical load displacement response for conventional constructed wallettes in previous research [24]

[25]. The curve was divided into four regions with the change of slope, while the point of inflection stands for the first cracking point, the ultimate load point and residual strength respectively. As stated above, the wallettes tested in this project shows different behaviour before failure. It may be argued the bond condition at the joint might be different due to the potential micro-cracking in material, some weaker bond parts is start to fail while the stronger parts are beginning to get involved, this lead to an increase of the stiffness and give a non-linear behaviour in the graph. As the weaker areas fail but the remaining bond is stronger and stiffer than the failed parts, which resulting in the unusual behaviour. Similar behaviour has been observed by Kanyeto [26] for the experimental work carried on concrete blockwork.

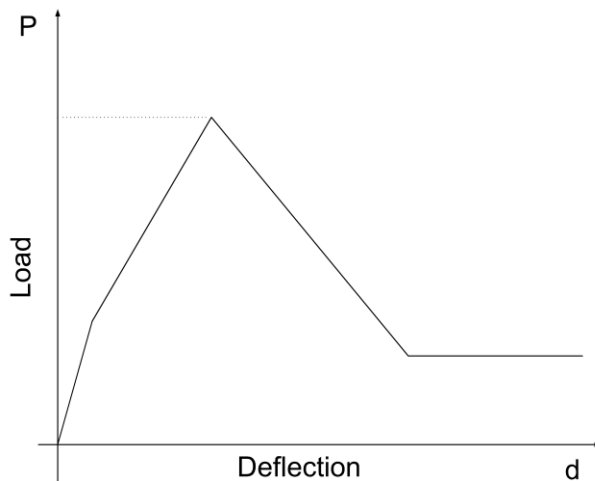
Figure 16 Idealised wall horizontal flexure behaviour [24]
